**DOCKET NO.: SA-517**  
**EXHIBIT NO. 9F**

**NATIONAL TRANSPORTATION SAFETY BOARD**  
**WASHINGTON, D.C.**

**SYSTEMS GROUP CHAIRMAN'S FACTUAL REPORT**  
**ATTACHMENT 5**  
**KOREAN AIR POST ACCIDENT TESTS**

Attachment 5  
Korean Air Post Accident Tests

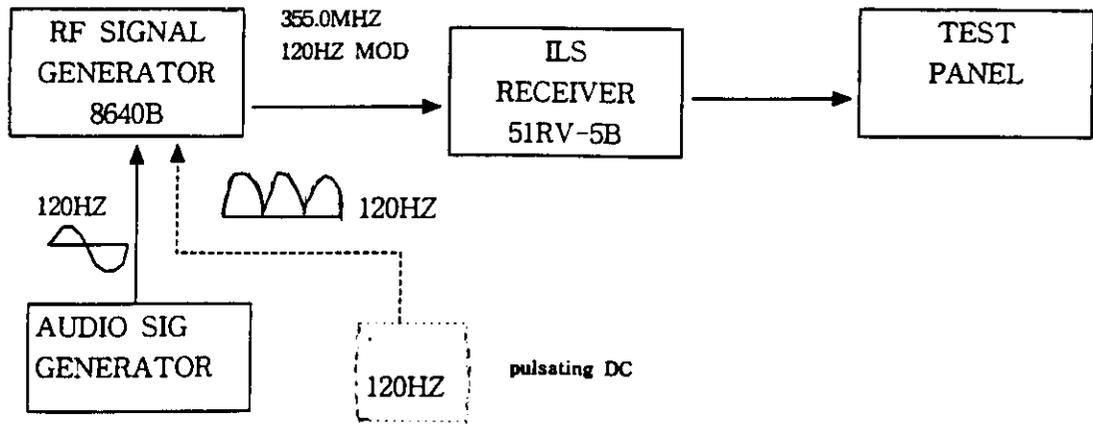
[Fig 1]

A 335 MHz test signal (ILS frequency of 110.3 MHz), -90dBm, 120 Hz modulation at 100% was applied to the ILS receiver under test while the glide slope indicator and flag were monitored for movement. **Reference Figure 1 of block diagrams for test setup.** The following results were noted:

<u>Receiver</u>	<u>Glide Slope indicator deviation</u>	<u>Flag</u>
51RV-5B	-58 mV	out of view
51RV-1	-5 mV (centered)	out of view
51RV-2B	-58 mV	out of view (at 270mV)
ILS-70	-1.01 v	out of view
RIA-32A	n/a	in view
ILS-700 series	n/a	NCD (no computed data)

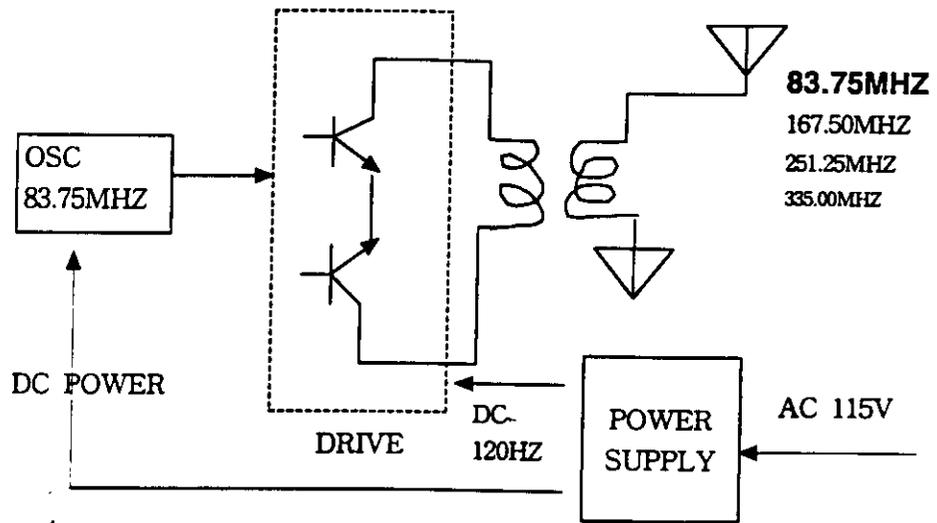
[Fig 2]

The test was repeated with the same results using a radio transmitter powered by a full wave rectified DC with the oscillator frequency set at 83.75 MHz (one fourth of 335 MHz). **Reference Figure 2 of block diagrams for test setup.**

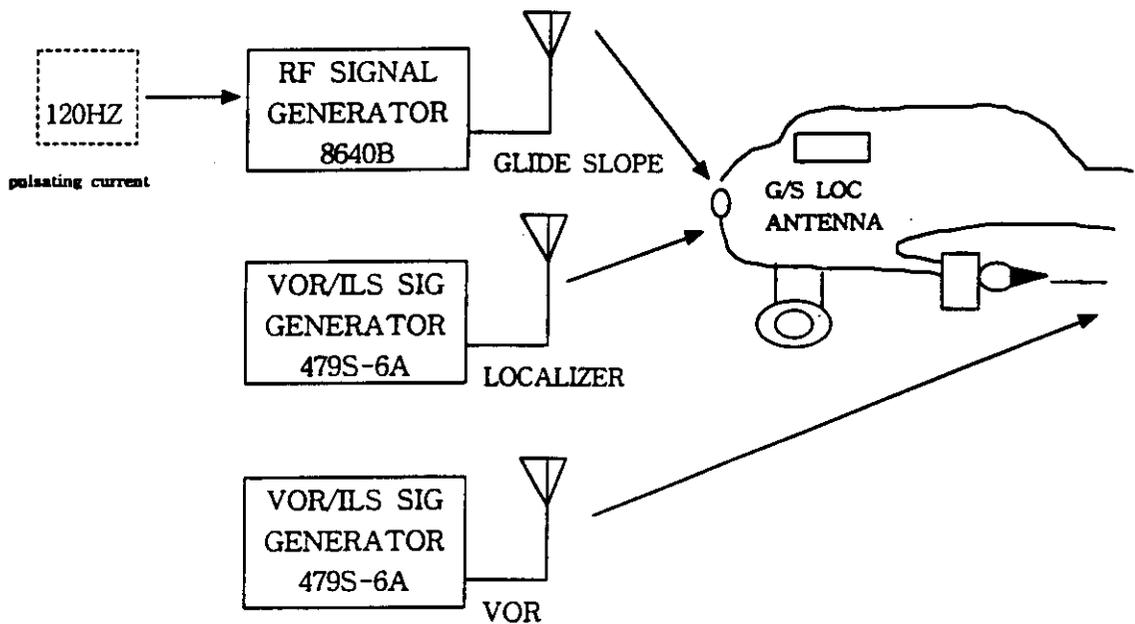
[Fig 3]

The test was repeated on an airplane on the ground with 120 Hz pulsating current feeding the RF signal generator. **Reference Figure 3 of block diagrams for test setup.** The indications recorded were:

VOR tuned to 115.3 MHz, course set as 063: NAV capture  
NAV tuned to 110.3 MHz: LOC, GS flag out of view  
LOC Center, GS 0.8 Dot up  
FD Green NAV. White GS
