GE 536 Occurrence Investigation Report

Runway Overrun During Landing On Taipei Sungshan Airport

TRANSASIA AIRWAYS FLIGHT 536

A320-232, B-22310

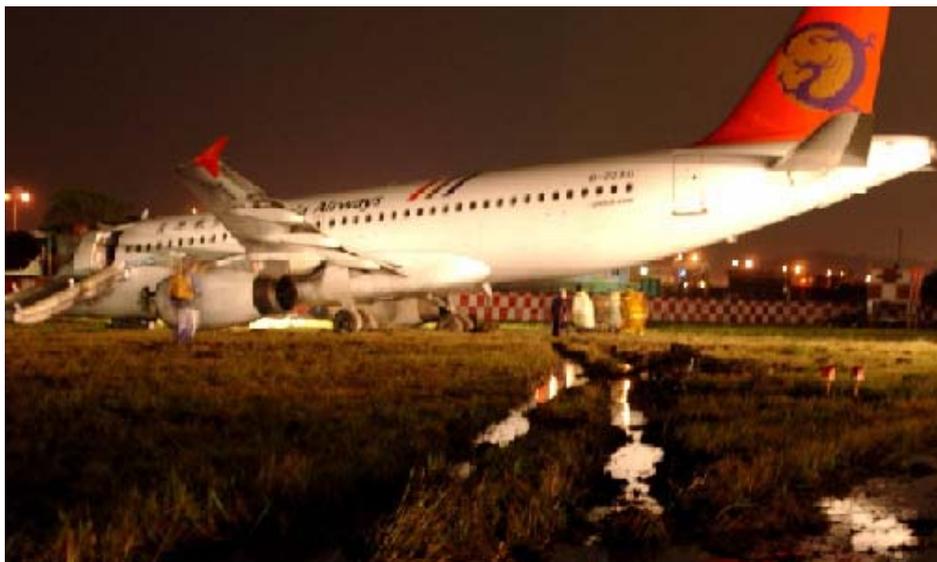
Figure 1.3-1 The aircraft rolled off runway and came to rest in a muddy area 90 degrees to the runway heading

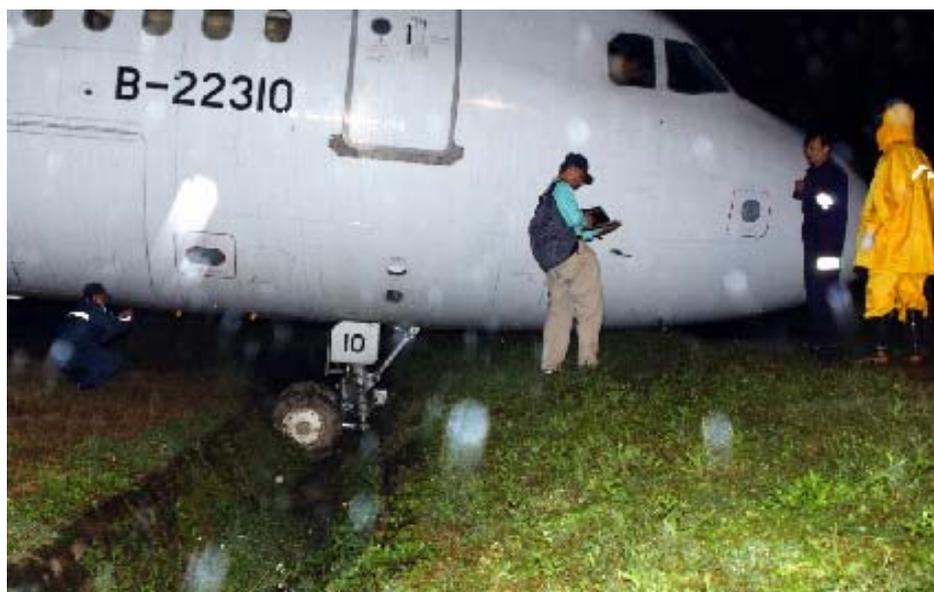
Figure 1.3-2 The NLG entered a drainage ditch (approx 1m deep)

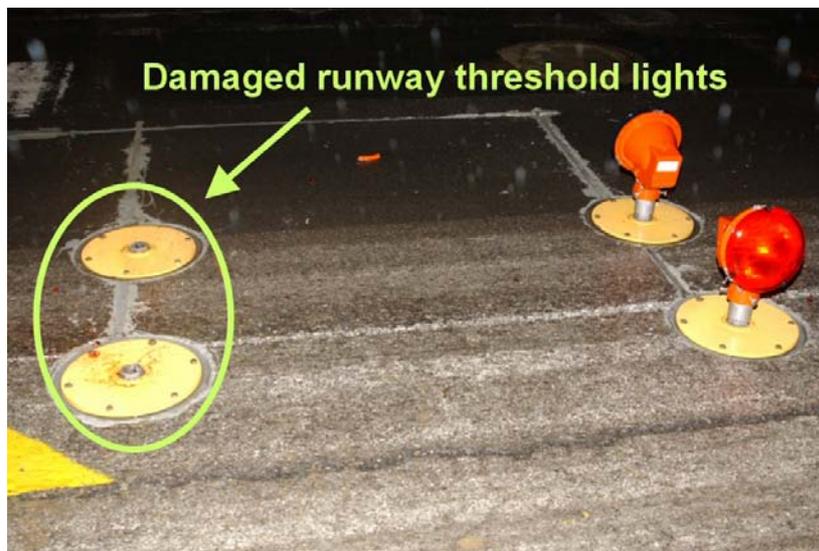
From the observation of the tire marks, the nose gear passed through two runway threshold lights (Figure 1.4-1) . The right main landing gear passed through two electrical handholds. Wreckages of the damaged electrical handholds were shown in Figure 1.4-2.

Figure 1.4-1 Damaged runway threshold lights

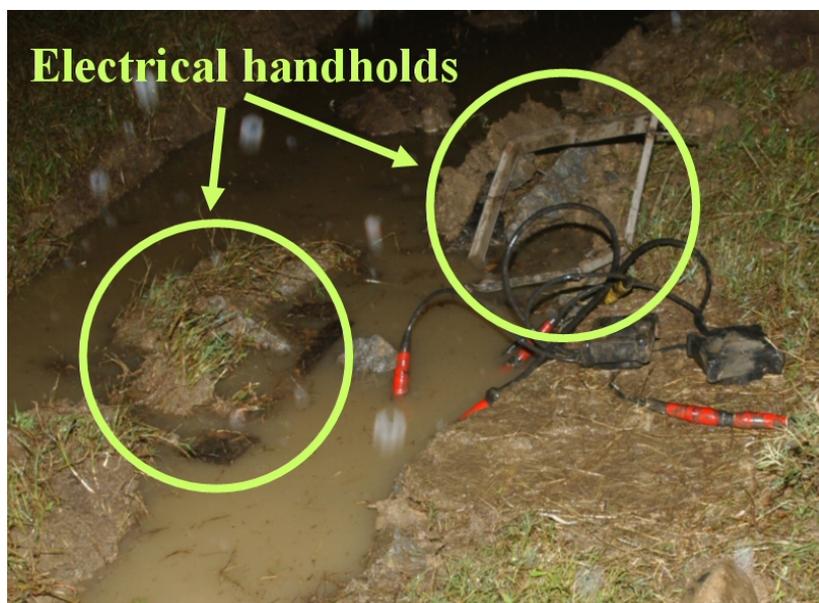
Figure 1.4-2 Damaged electrical handholds

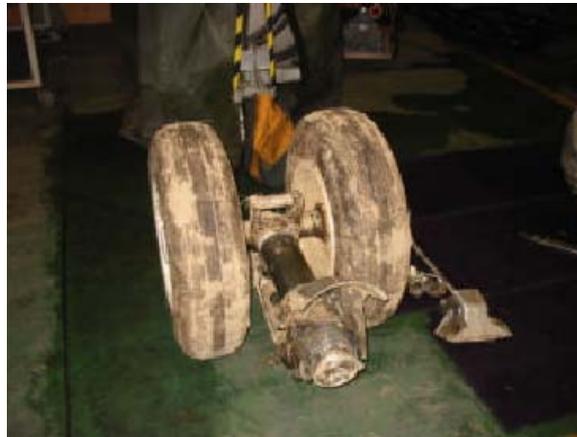
- No visual damage noted at the NLG attachment or to the bay structure.
- Sliding tube broken and associated harnesses destroyed (Figure 1.12-2,3) .
- NLG Aft door (LH and RH) damaged during recovery (Figure 1.12-4) .

Figure 1.12-2NLG Sliding tube broken and associated harnesses destroyed

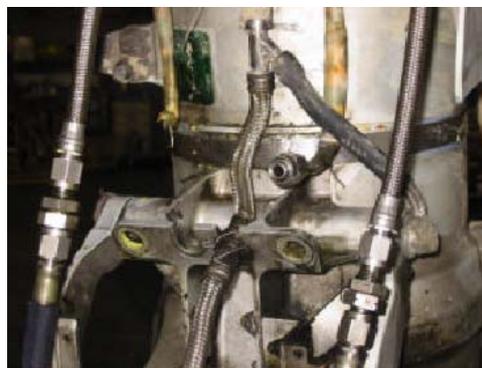
- No visual damage noted at the MLG attachments or to the bay structure.
- Damage noted to LH tire due to contact with runway object.
- LH and RH MLG experienced damage to the electrical and hydraulic systems on the casing during recovery. Compression of the systems against casing has scratches to the surface of both assemblies (Figure 1.12-5, 6)
- LH MLG door minor seal detachment noted. Not considered occurrence related.

Figure 1.12-5 LH MLG electrical and hydraulic systems damage

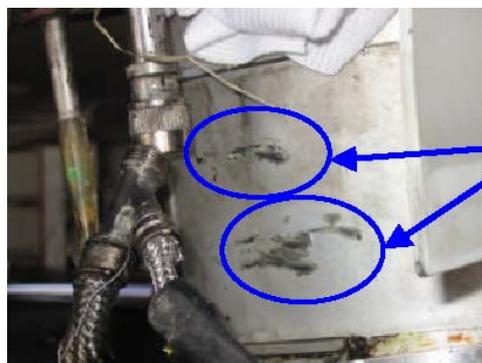
Figure 1.12-6 LH MLG Scratches – max depth 0.5mm

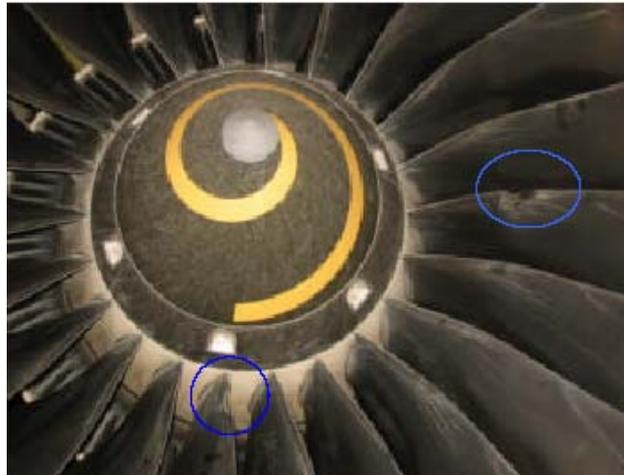
- Three fan blades and cone damage (Figure 1.12-7, 8) ;
- 5 damage locations noted on the LH Nose cowl (four on the inner surface and one external) (Figure 1.12-9, 10) .

Figure 1.12-7 Fan damage

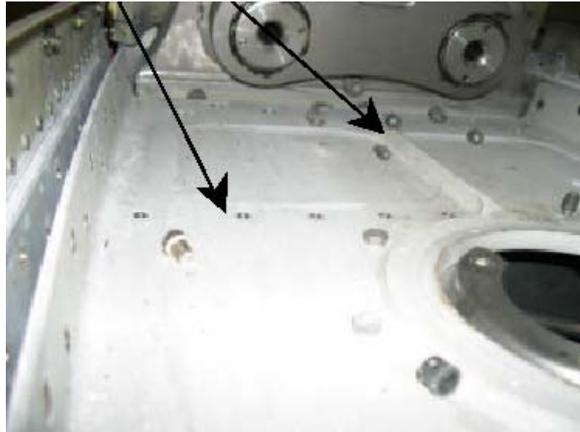
Figure 1.12-17 Upper Panel Pulled fasteners

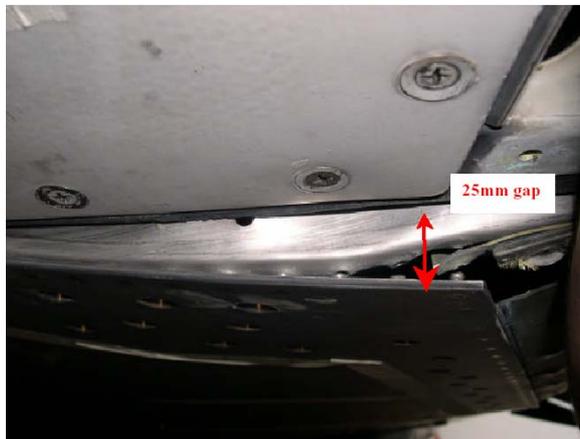
Figure 1.12-18 Internal profile deformed.

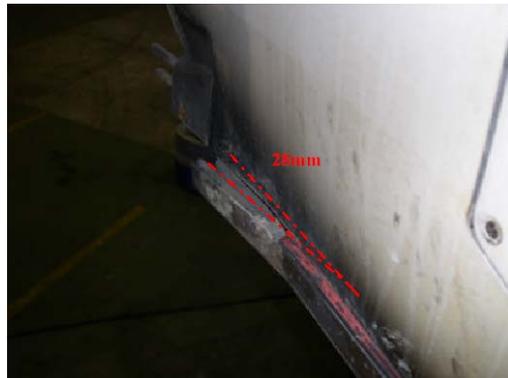
Figure 1.12-19 Twisting of the lower profile

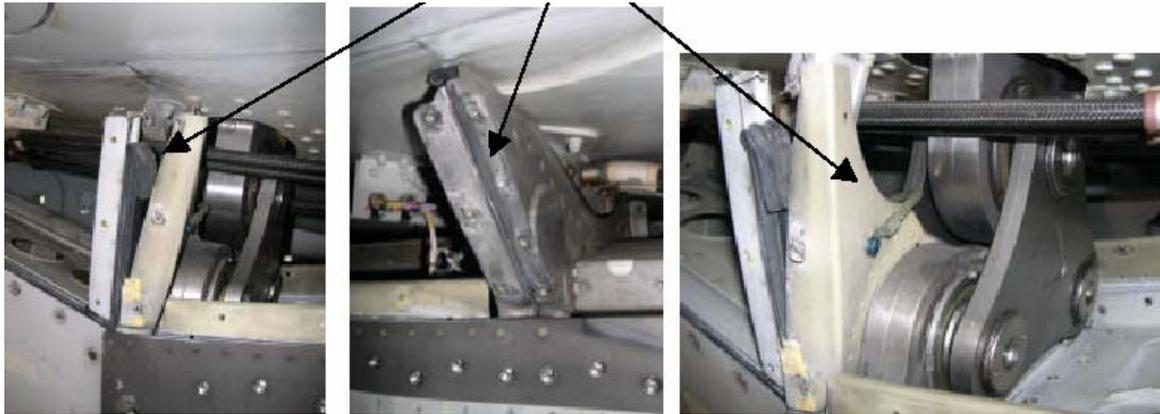
Figure 1.12-20 Vertical Profiles deformed

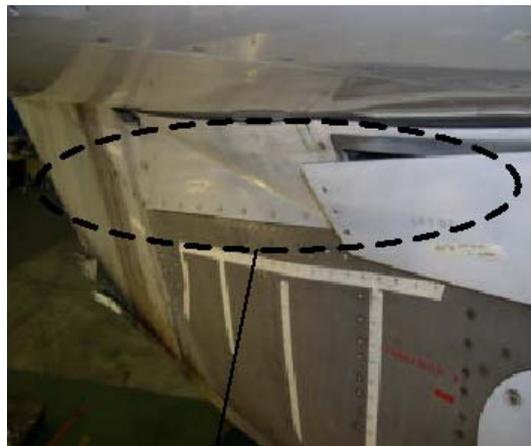
Figure 1.12-21 Fairings deformed

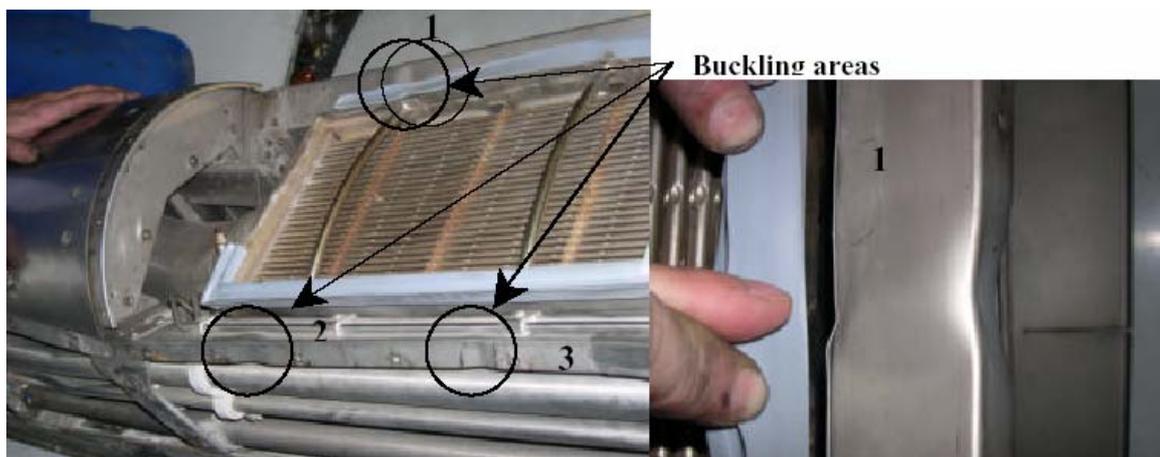
Figure 1.12-22 Upper cantilever angle buckling

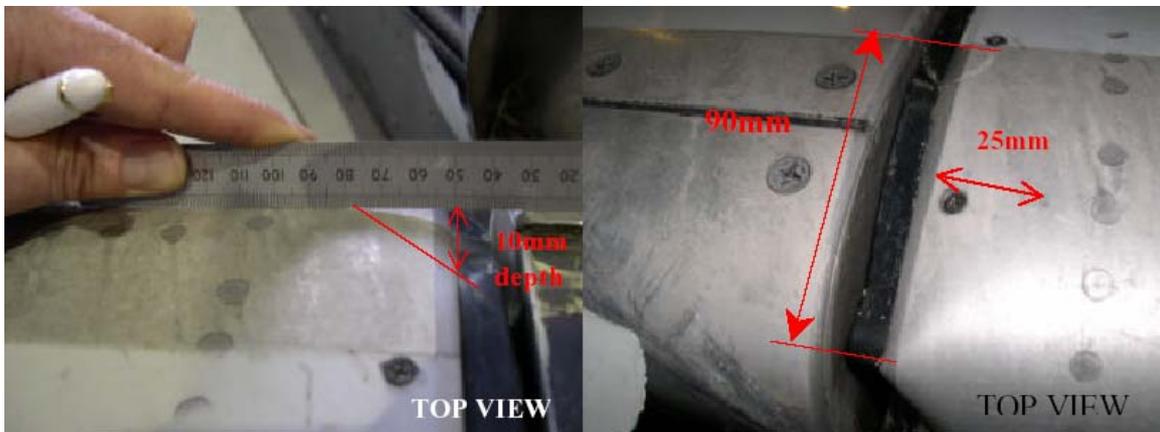
Figure 1.12-24 leading edge upper skin exhibited a 25mm x90mm dent

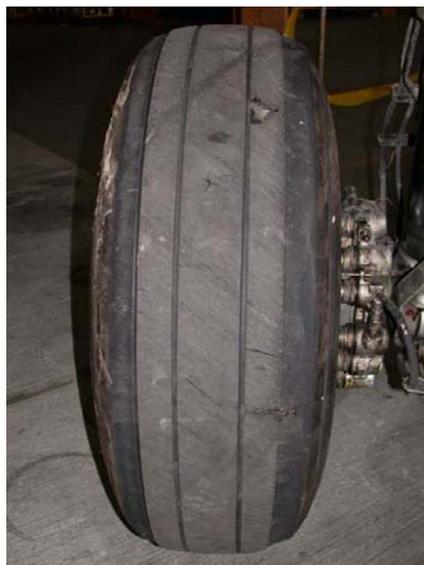
All four tires had deep cut damage (depth up to tread reinforcing ply) and diagonal scratch marks, as shown in Figure 1.16-1. There is no tread rubber reversion present.

Figure 1.16-1 Deep cut damage and diagonal scratch marks

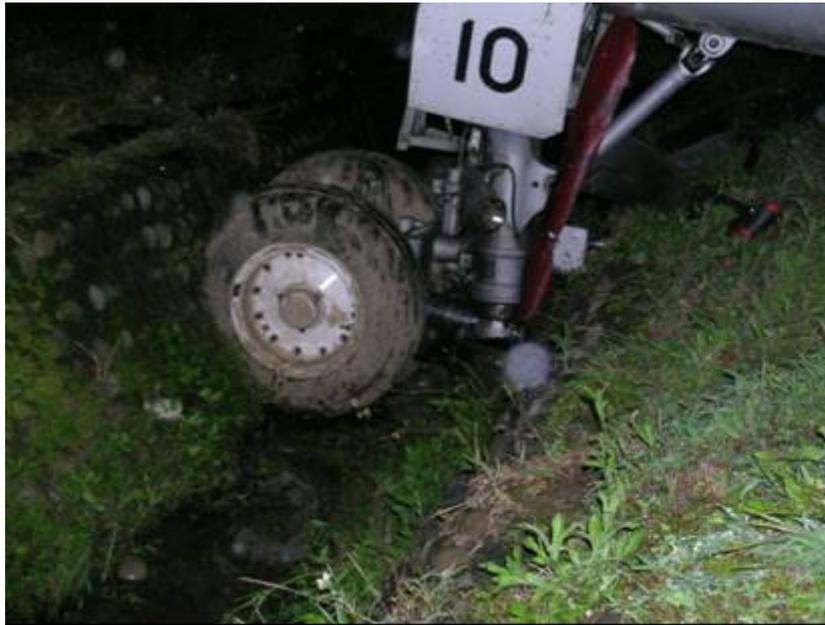
Figure 1.18-2 The nose gear stopped in the ditch

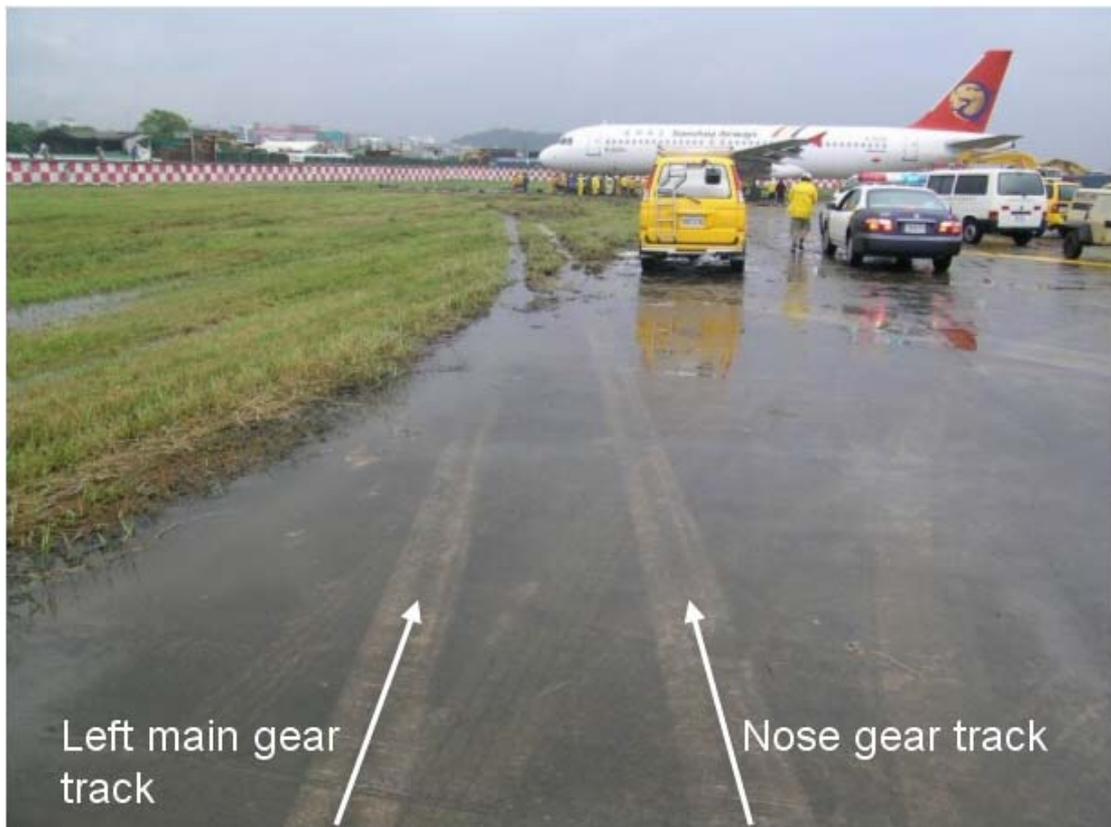
The tire marks of the aircraft could be tracked from the grass area, via the pavement of the stopway, continuously to the runway threshold markings of Runway 28 (Figure 1.18-3). No apparent tire marks of the occurrence aircraft could be found on the runway.

Figure 1.18-3 Ground tracks from the stopway pavement to the grass area
