GE 536 Occurrence Investigation Report

Runway Overrun During Landing On Taipei Sungshan Airport

TRANSASIA AIRWAYS FLIGHT 536

A320-232, B-22310

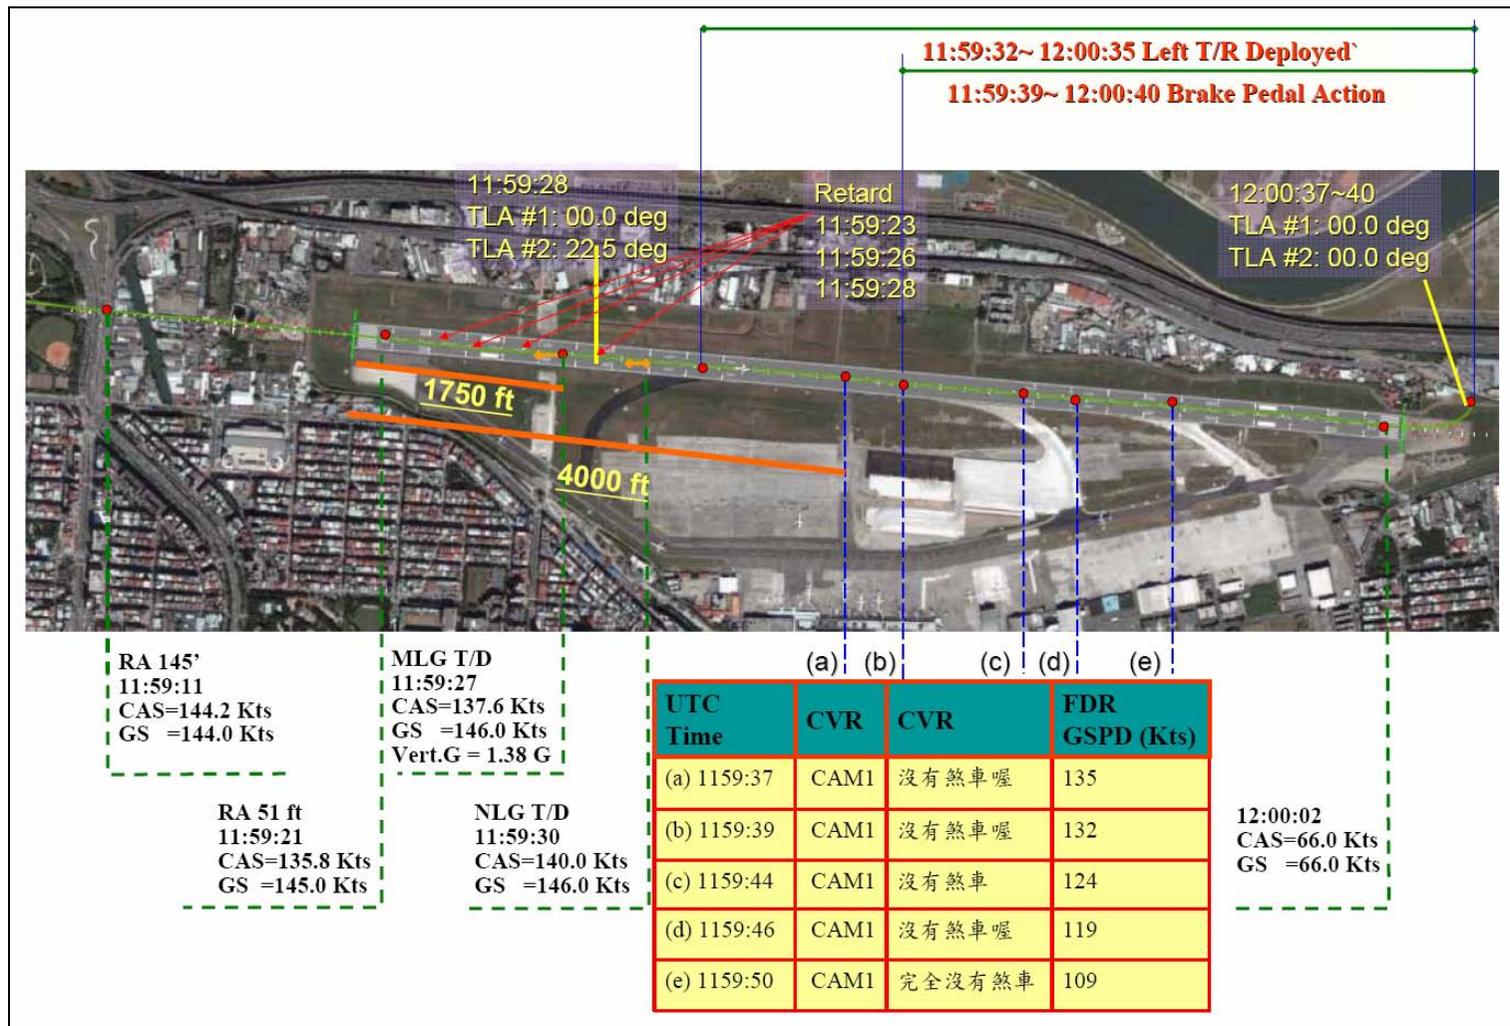
Figure 1.11-3 Superpose of Flight Path and Satellite Image (Time, Flight Path, FDR Parameters, and CVR Transcripts)

The touched ground position and timing is determined by parameters of "Landing Gear RH/LH Compressed Shock Absorber" and maximum vertical acceleration, as shown in Figure 1.11-3. At 1959:27, main landing gear touched ground at 1,750 feet beyond the threshold of runway 10. At 1959:37, Captain called out "No brake", the GE536 located at 4,000 ft beyond the threshold of Runway 10.

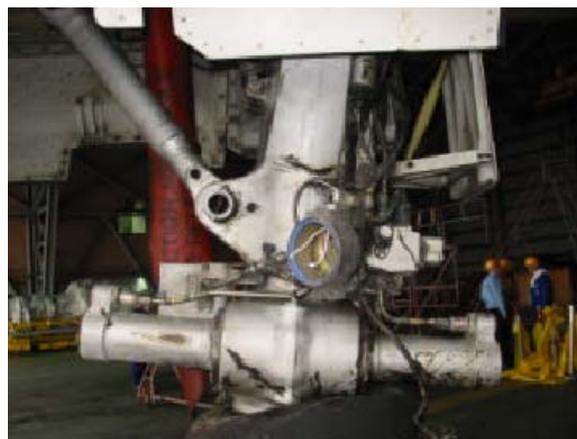
Figure 1.12-3NLG without broken sliding tube

- No visual damage noted at the NLG attachment or to the bay structure.
- Sliding tube broken and associated harnesses destroyed (Figure 1.12-2,3) .
- NLG Aft door (LH and RH) damaged during recovery (Figure 1.12-4) .

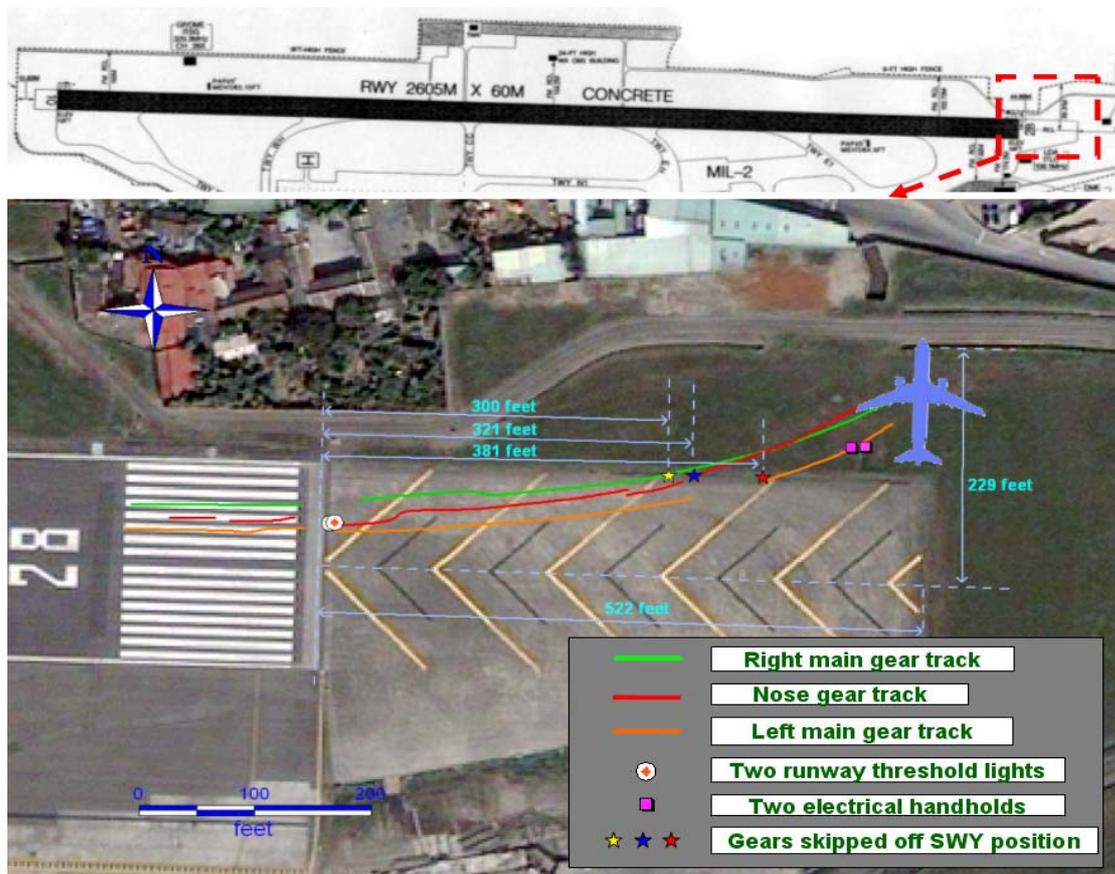
Figure 1.18-1 Sunghshan airport chart and site-survey results with the satellite image

The result of site survey was presented on the airport satellite image as shown in Figure 1.18-1. The ground tracks of left main landing gear, right main landing gear and nose gear were represented with green, orange and red lines respectively.

According to the site-survey result, the nose gear of the occurrence aircraft skipped off the pavement of the stopway at 321 feet outward the threshold of Runway 28. The nose gear stopped in the uncovered ditch at about 130 feet in the north of the stopway (Figure 1.18-2). The aircraft stopped with heading 002 and nose downward slightly.

The tire marks of the aircraft could be tracked from the grass area, via the pavement of the stopway, continuously to the runway threshold markings of Runway 28 (Figure 1.18-3). No apparent tire marks of the occurrence aircraft could be found on the runway.

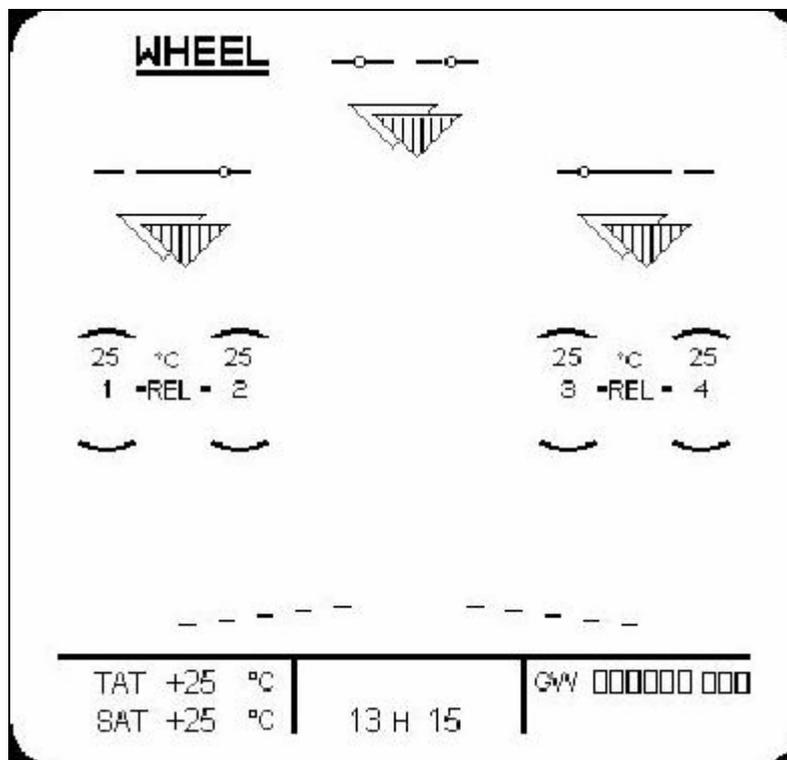
Figure 2.3-4 An ECAM display shows the ground spoilers are not extended

When the ground spoiler is deployed during normal touchdown, the indications to which the arrow pointed on ECAM WHEEL PAGE, see Figure 2.3-3, are green; if the ground spoilers are not deployed, the indications are such as shown in Figure 2.3-4 and the symbols “ - ” are green.

At 1959:27hr, the LH/RH landing gears touched down simultaneously. At 1959:29 hr, CM-1 declared “spoiler one reverse green and”. According to the analysis of Sec.2.3.3.2, as the ground spoilers were not activated and extended, the indications on ECAM screen should be “-”, as figure 2.3-4 shows. While his flight hours have exceeded 8700 hours, CM-1 is supposed to be quite familiar with the touchdown announcing practice. The ECAM page has shown that the ground spoilers were not extended, but “spoiler” was announced automatically, without any effective ECAM check. This could be translated into that the pilot did not check ECAM indications according to the requirements of SOP before announcing. Also, due to raining, tail wind, and at that time only the reverser in one side of the aircraft could be activated which tended to cause excursion, the pilots’ attention was focused on the rolling direction and deceleration, thus the retraction of ground spoilers was ignored.

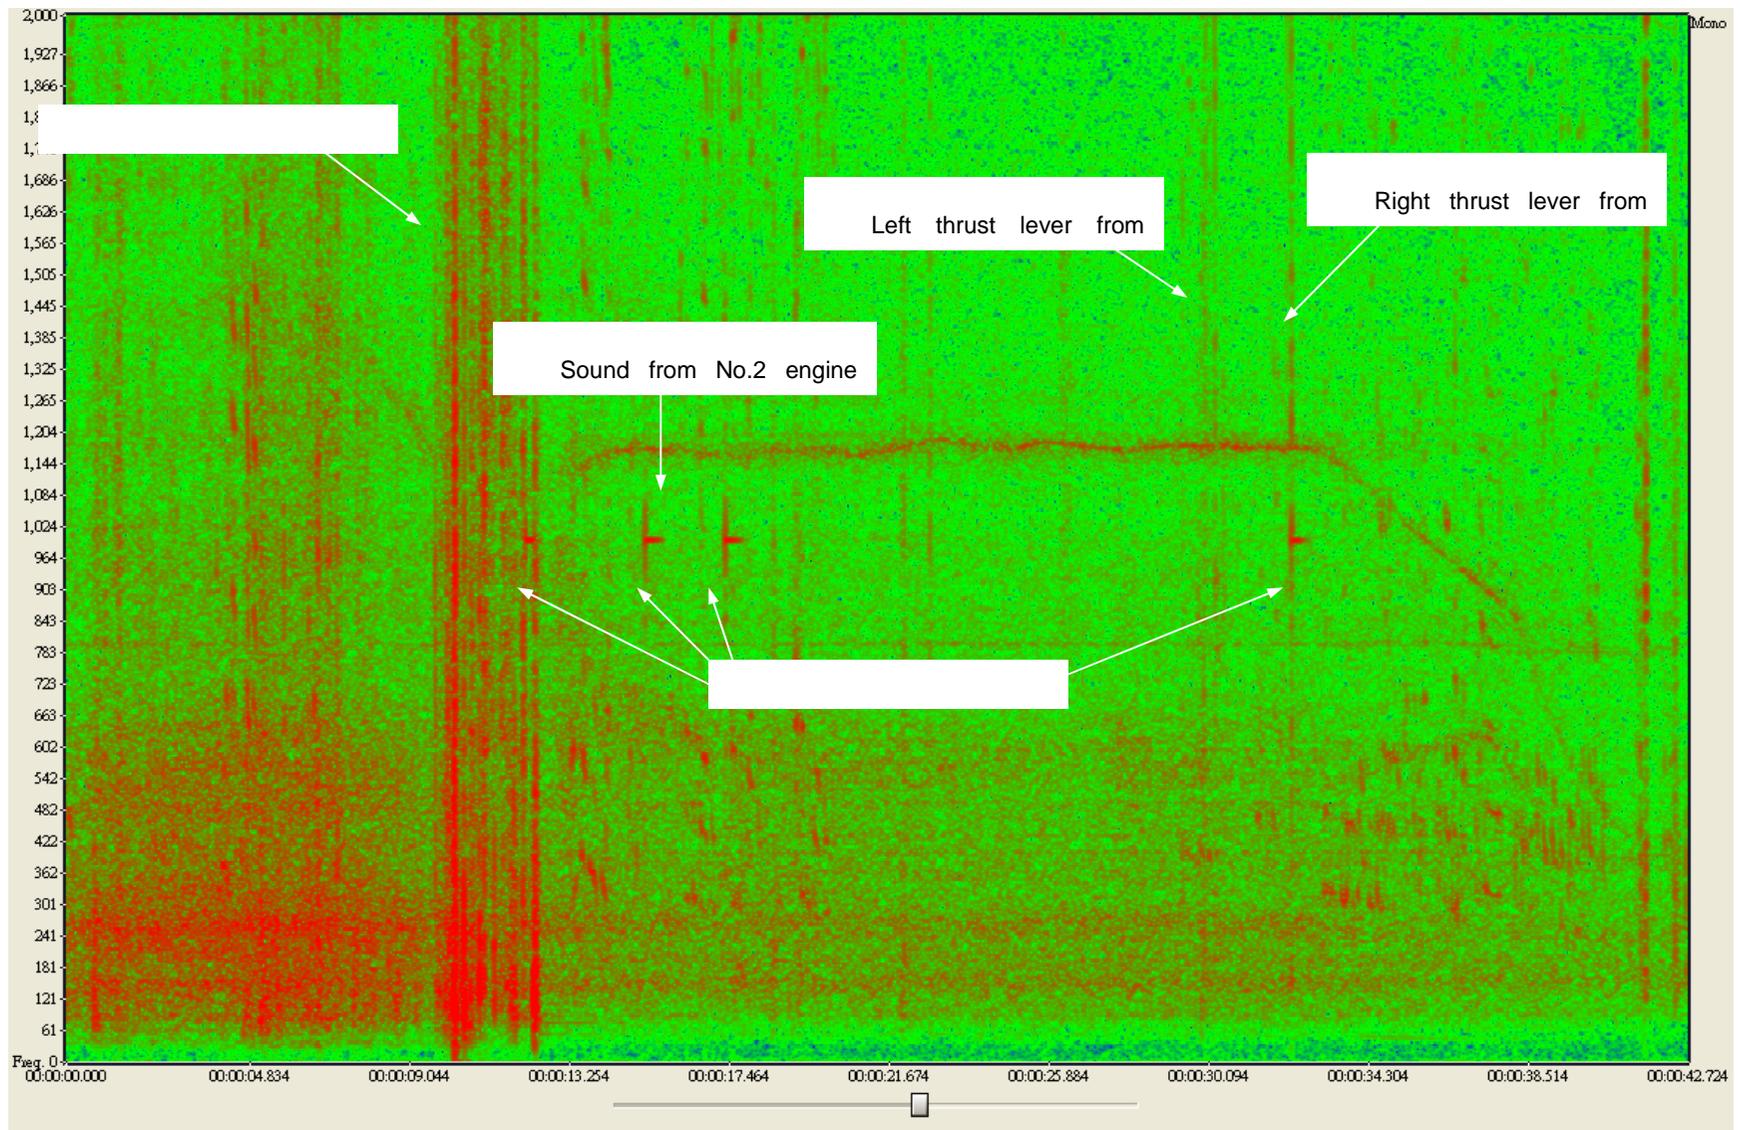
圖二 撞擊前後之譜頻能量圖
